NPIC/R-1453/64

September 1964

PHOTOGRAPHIC INTERPRETATION REPORT

# MILITARY STORAGE AREA NEAR NAN-KOU, CHINA

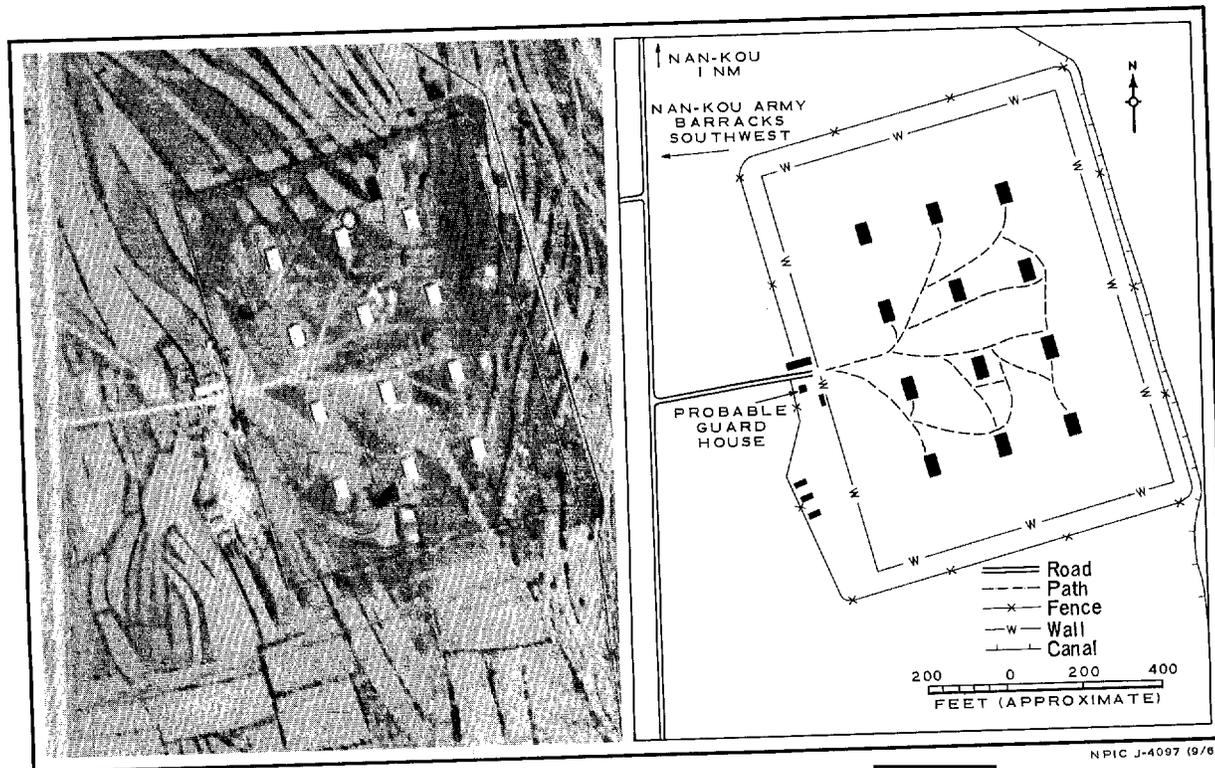
FIGURE 2. MILITARY STORAGE AREA NEAR NAN-KOU, CHINA, [REDACTED]

Storage Buildings. The storage area meas-

ures 900 x 1,200 ft and contains four rows of three buildings each. The buildings are evenly spaced; the distance between them is 125 ft. Each building is gable roofed and measures 55 x 40 ft (Figure 2). The total floorspace of storage in the buildings is 26,400 sq ft.

The buildings are served by an informal pattern of paths which radiate from the site entrance [redacted]

Security. A small building, probably a guard house, and a building measuring 70 x 35 ft are located just outside the entrance to the area. Visible security measures consist of a perimeter fence and an enclosing wall. No guard towers or facilities for lighting were observed.
